Introduction

Partial discharges (according to IEC standard 60270) are harmful electrical discharges in electrical systems. The early detection of these anomalies, as well as the identification of the exact location of the emission, will help to carry out corrective actions on time and with high efficiency. These discharges release energy from time to time, creating a distinctive acoustic signature that can be captured by an ultrasound listening device (ULD).

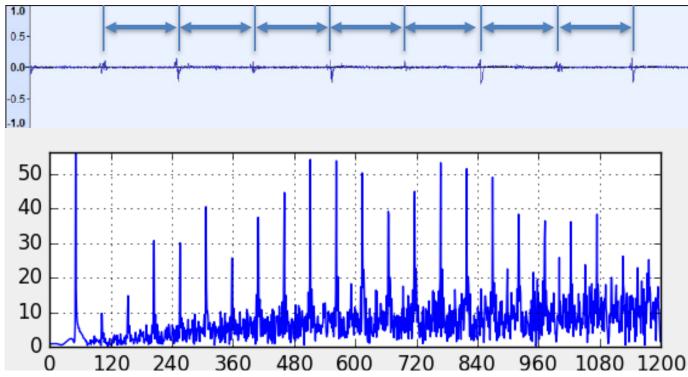
The ultrasonic signature of the Corona Effect is very characteristic: a buzz type background sound, with blows on it that are equivalent to the individual discharges. These blows, as seen in the waveform graph at the top of figure 1, are very constant in time series and are on the same frequency as electric power; 50 Hz or 60 Hz depending on the country where they are taken. By having broad redundancy of the discharges, they generate a spectrum full of harmonics, as shown in the frequency spectrum (FFT) of figure 1.

Fig. 1: Ultrasonic signature of Corona Discharge

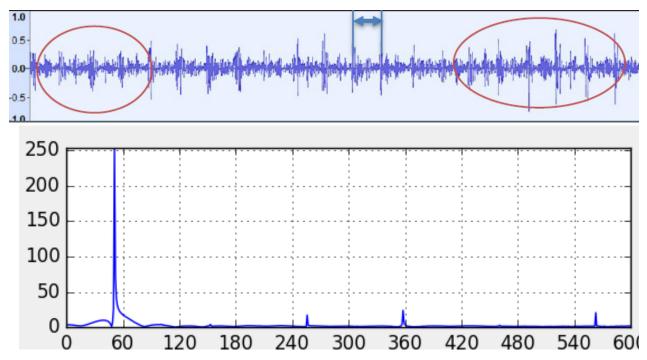
Fig. 2: Ultrasonic signature of the Tracking Discharge.

The monitoring pattern is erratic as seen in figure 2, since the discharges occur irregularly in the waveform of the electric current (meaning, each shock of discharge has a component in the frequency of the electrical energy.) However, the discharge is very active as can be seen in the red circles. This can be seen in the decrease in harmonic peaks in the frequency spectrum (FFT), where there are peaks in 50 Hz or 60 Hz (depending on the electrical frequency of each country), but these are hidden since the behavior of the signal is irregular.

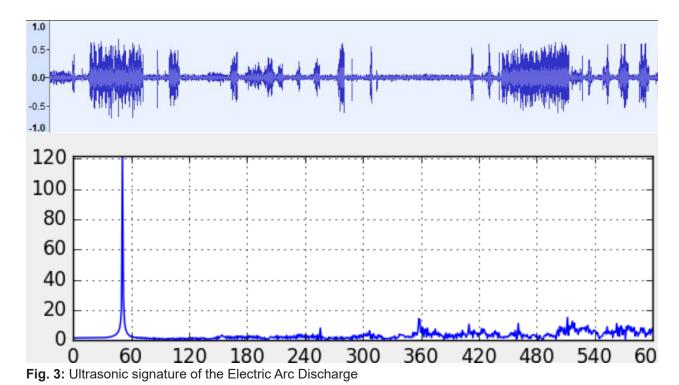
In figure 3 we can see a great difference between small discharges against energy blocks that are equivalent to the discharge of the electric arc. When we find an electric arc, we are facing a security risk and an imminent failure, so immediately action must be taken to prevent further damage.

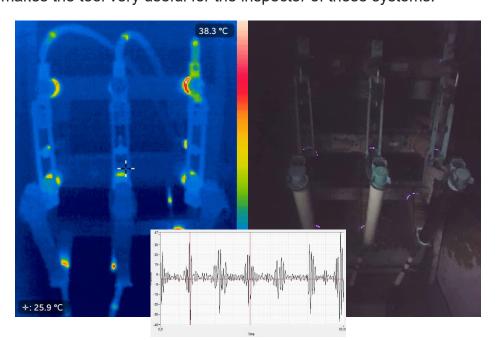
Fig. 4: Inspection of Medium Voltage Cell by Acoustic Ultrasound and IR Camera

The separate ultrasound helps plant personnel to follow the protocol for opening cabinets and closed electrical panels, allowing them to listen behind a door to any abnormal situation. This can help us make decisions that affect the safety of inspectors, such as preventing them from opening a door with a potential problem behind it. In figure 4 we can see that an anomaly was detected with ultrasound without the need to open the cell door. To see the anomoly with thermography, an IR peephole or fireproof suit should be used.
